P-3 SERVICE LIFE ASSESSMENT PROGRAM (SLAP) –
A HOLISTIC APPROACH TO INVENTORY SUSTAINMENT FOR LEGACY AIRCRAFT

Nam D. Phan
Head, Support and Rotary Wing Aircraft Strength Branch
United States Navy, Naval Air Systems Command
47123 Buse Road, Patuxent River, MD 20670

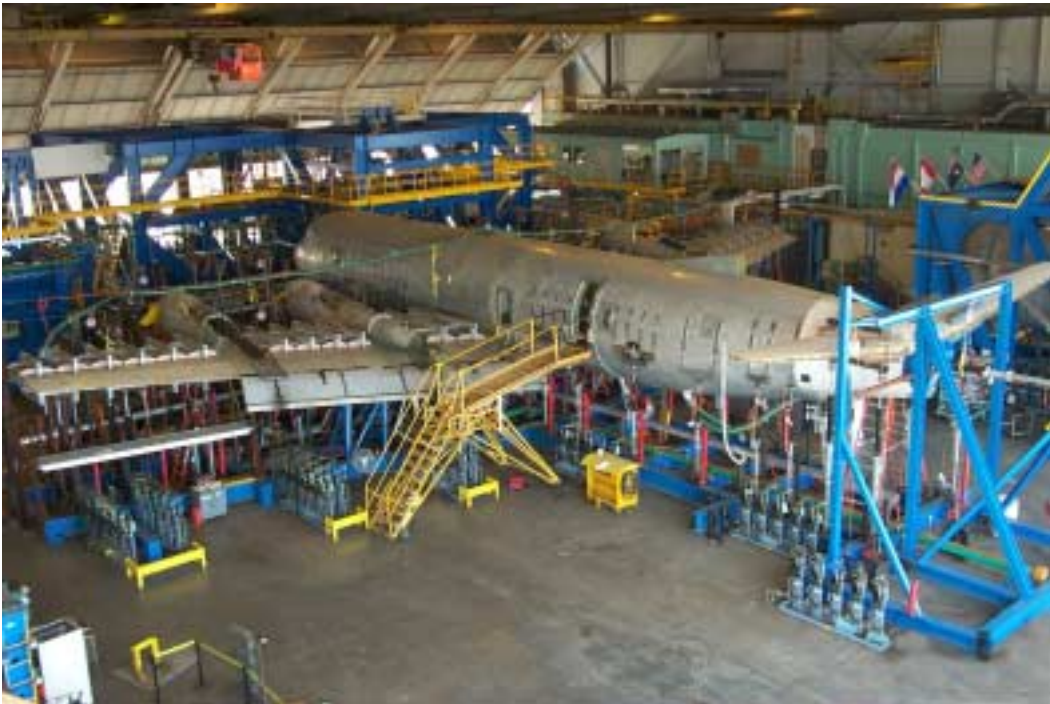
FIGURE 3 – P-3C Full Scale Fatigue Test Article

The Multi-mission Maritime Aircraft (MMA) will eventually replace the aging P-3 fleet as the long-term solution for broad area maritime and littoral armed intelligence surveillance and reconnaissance. However, since the MMA Initial Operational Capability (IOC) is not expected until the FY12 timeframe, the USN will continue to rely on the existing P-3 fleet for the foreseeable future. The USN and its FMS partners - Canadian Forces (CF), Royal Australian Air Force (RAAF) and Royal Netherlands Navy (RNLN) – proactively initiated the P-3C SLAP to re-assess the P-3C fatigue life in 1997. This program also determines structural inspections, modifications, replacements and redesigns necessary to sustain the P-3C fleet to at least the year 2015. Since material condition, obsolescence and supportability/maintainability issues associated with aging airframes significantly affect the TOC, other material and process improvements were also evaluated for potential fleet implementation (see Figure 2). The SLAP Full Scale Fatigue Test (FSFT) confirmed the analytical predictions and provided a test bed for the newly developed materials, designs, and processes (Figure 3).

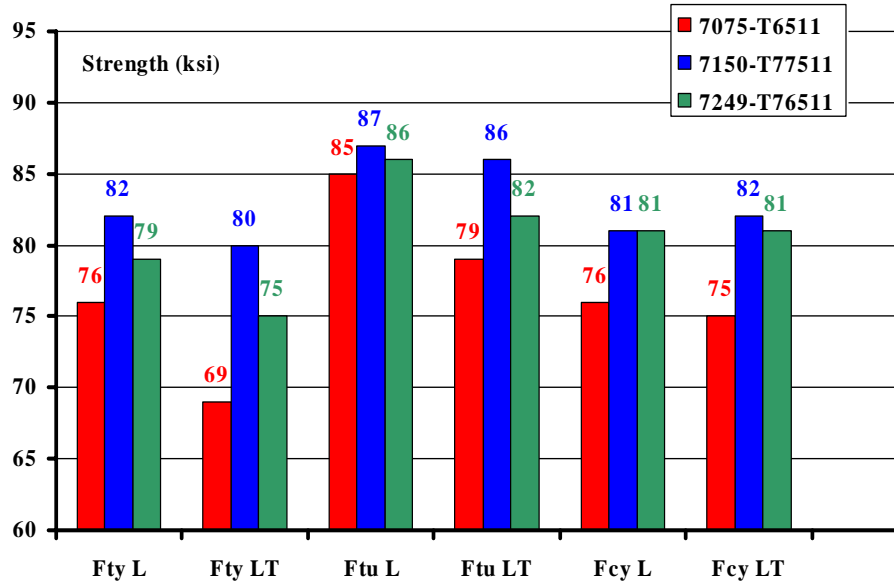
Wide Extrusions

Mechanical Property Comparison (Proposed B-Basis)

FIGURE 5 – Wide Extrusion Mechanical Property Comparison

ALCOA produced 7150-T77511, a proprietary heat-treated temper, for both narrow and wide extrusions. Spectrulite Consortium Inc. and Universal Alloy Corporation optimized the heat-treatment process for the non-proprietary 7249-T76511 wide and narrow products (see Figure 5). Both non-proprietary 7055-T74511 and 7055-T76511, supplied by ALCOA, were evaluated as candidate replacements for narrow 7075-T6511 and 7178-T76 extrusions, respectively (see Figure 6). Aerospace Material Specifications (AMS) for these materials were developed and approved for general use by Society of Automotive Engineers (SAE) Committee D. Over 100 coupons for each alloy were tested to generate A and B basis design allowables, and this data has been submitted for inclusion in the Department of Defense Military Handbook 5 (MIL-HDBK-5). The USN also conducted six-month

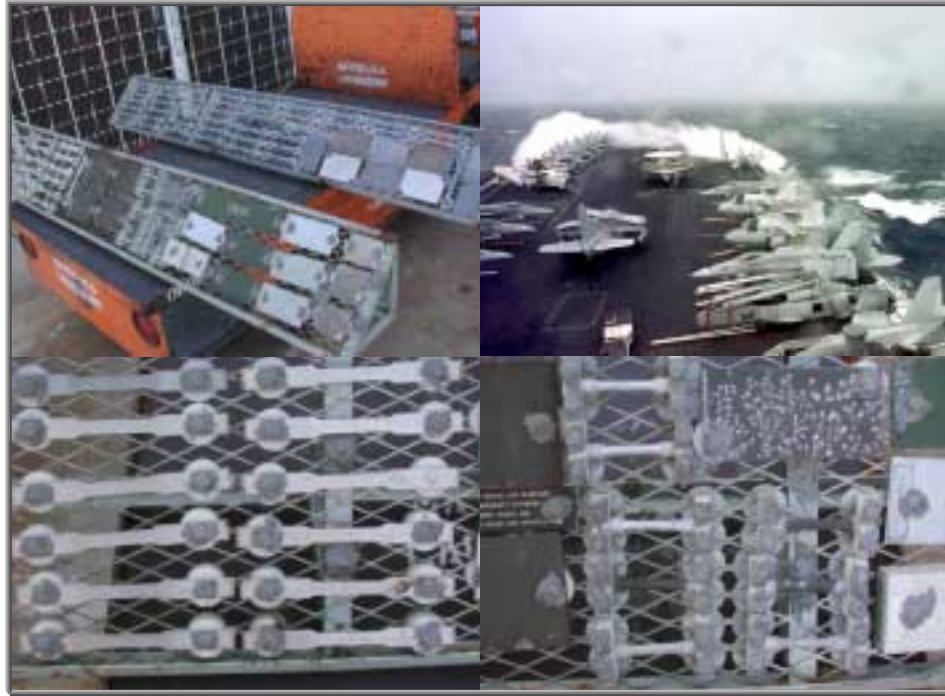
FIGURE 7 - Environmental Exposure Testing

environmental exposure testing for the new materials aboard aircraft carrier in the Indian Ocean (see Figure 7).

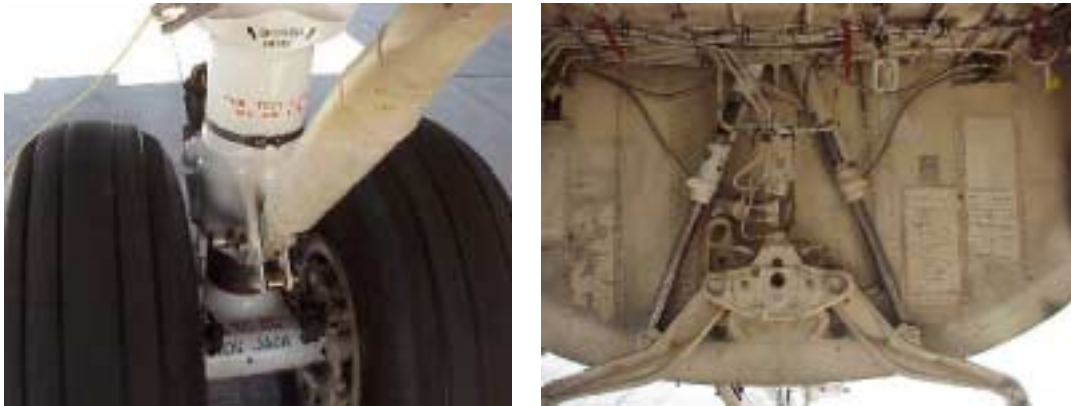
FIGURE 8 – HVOF Application on the P-3 Main Landing Gear Cylinder and Bomb Bay Actuators

The P-3 landing gear cylinders and bomb bay actuators were selected for HVOF application (see Figure 8). The certification program includes coupon and full scale testing, as well as in-service trial installations. Laboratory test results confirm properties equivalent to or greater than chrome plating; similar adhesion properties; increased hardness, wear, corrosion & impact resistance; reduced fatigue knockdown and hydrogen embrittlement susceptibility. On the SLAP P-3 FSFT, no anomalies were detected through 59,000 landing cycles, and a complete post-test destructive teardown of the landing gear is underway. To date, the in-fleet landing gear cylinder has accumulated over 2,000 landings and the bomb bay actuators have logged over 600 flight hours without any reported service discrepancies.

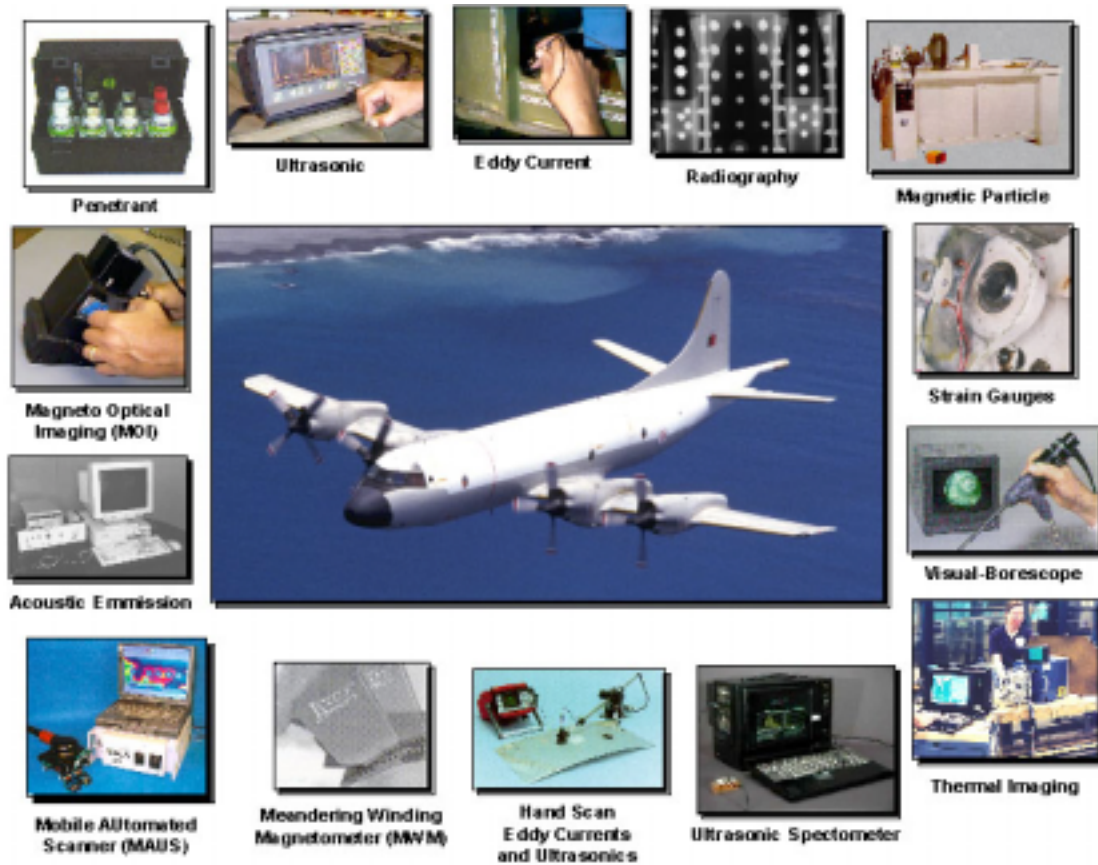
FIGURE 9 – NDI Toolbox

Another focus to reduce TOC is the assessment of current and emerging Non Destructive Inspection (NDI) technologies (see Figure 9). These state-of-the-art tools hold great promise for faster detection of smaller damage size with better accuracy. If successful, fleet implementation will result in earlier and less extensive corrective actions required, thereby lowering repair costs and increasing aircraft availability.

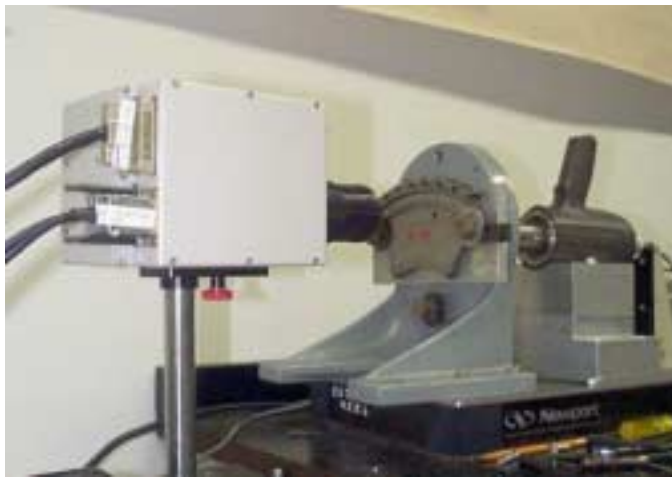
FIGURE 11 – Inspection of Compressor Disk using Sonic Thermography

Another promising crack detection technology evaluated is sonic (vibro) thermography. It utilizes infrared cameras to detect the heat generated by rubbing crack faces subjected to high-energy

ultrasonic energy. This detection method has been tested at NAS Patuxent River during the inspection of an aircraft engine compressor disk section (see Figure 11).

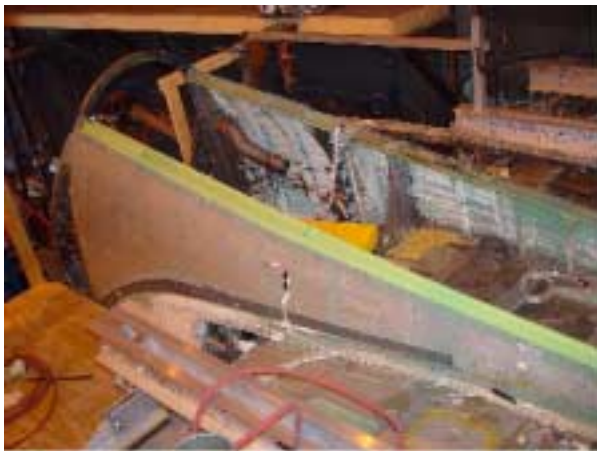
FIGURE 12 – One-piece Nacelle Upper Longerons

Nacelle Longerons. The existing 39-part spot welded nacelle upper longeron is difficult to fabricate and experiences cracking at the fore-aft segments' splice. The new design utilizes Computer Numerical Control (CNC) machining of 17-4 PH corrosion-resistant steel billet to reduce the total parts count to six (see Figure 12). This concept not only improves producibility but also eliminates the fatigue problem.

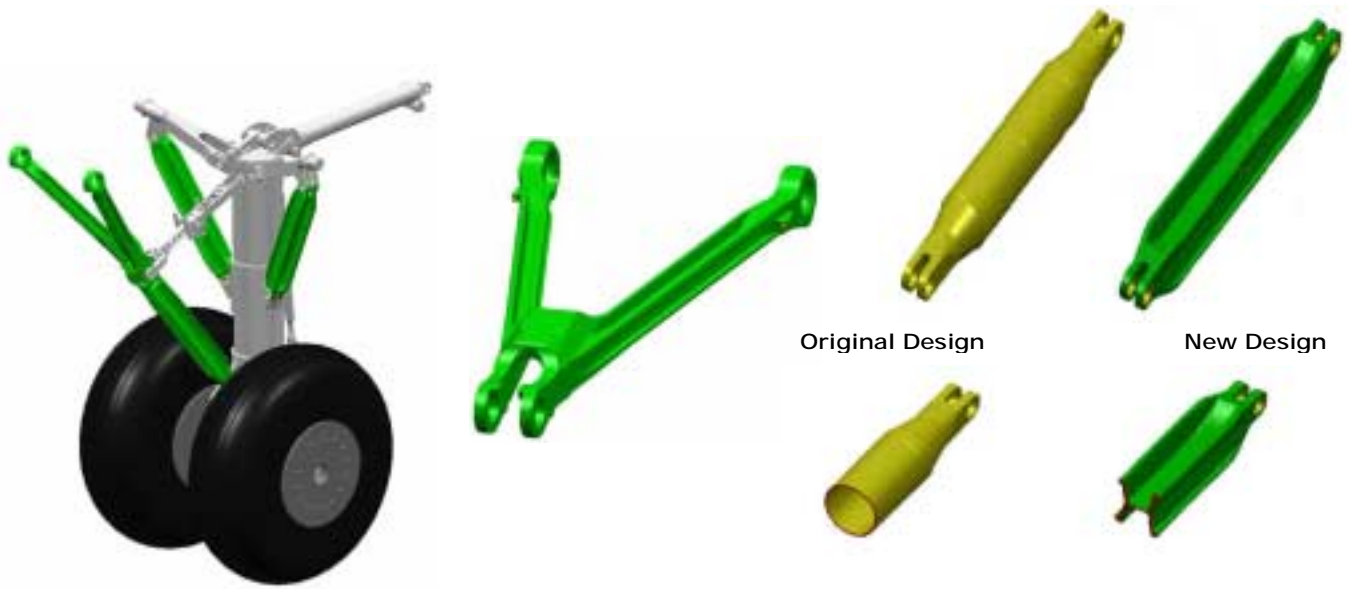
FIGURE 13 – Landing Gear Side Brace and Drag Strut Redesign

Landing Gear Drag Struts. The closed 4340 steel tube design of the drag strut promotes corrosion damage due to its tendency to trap moisture. It also hinders internal inspection and the ability to rework. Furthermore, complex manufacturing techniques coupled with a dearth of vendors have made parts hard to come by. The new strut utilizes CNC-machined AERMET 100 steel with an open section design (see Figure 13). This concept will significantly enhance producibility and facilitates inspection and rework.
