Alloys Used in an Aerospace Launch Environment

Rust 2003

Louis MacDowell
NASA/Kennedy Space Center

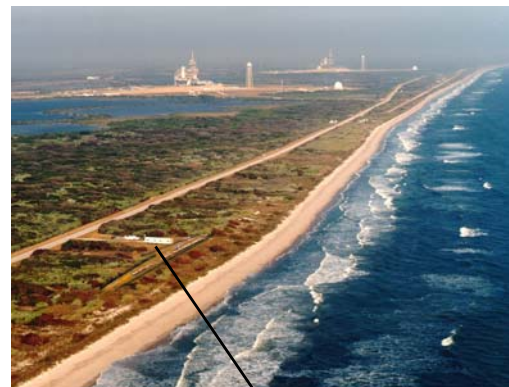
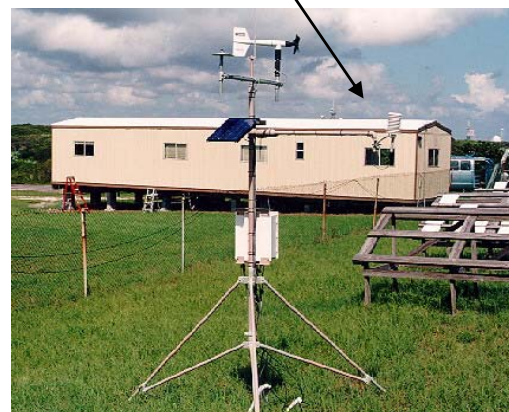
KSC Beach Corrosion Test Site

- Site actively maintained for over 35 years.
- Historical database is very helpful for evaluation of new materials.
- Side-by-side commercial coating test and evaluation is conducted for inclusion in NASA coating standards.
- Site instrumented for complete weather information.
- On-site laboratory performs real time atmospheric and immersion corrosion investigations.
- Network connectivity is available for data acquisition and real time video by the internet.

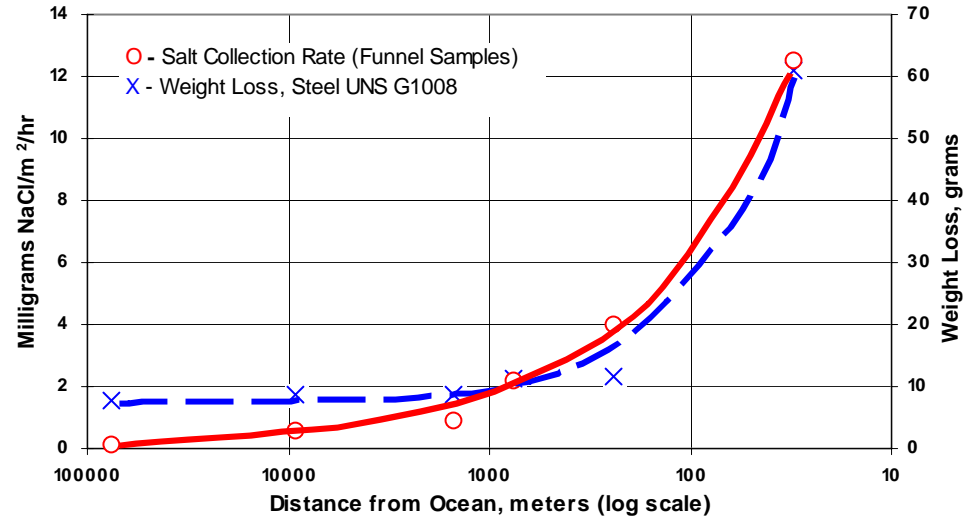
KSC Beach Corrosion Test Site

Location	Type Of Environment	$\mu\text{m}/\text{yr}$	Corrosion rate (a) mils/yr
Esquimalt, Vancouver Island, BC, Canada	Rural marine	13	0.5
Pittsburgh, PA	Industrial	30	1.2
Cleveland, OH	Industrial	38	1.5
Limon Bay, Panama, CZ	Tropical marine	61	2.4
East Chicago, IL	Industrial	84	3.3
Brazos River, TX	Industrial marine	94	3.7
Daytona Beach, FL	Marine	295	11.6
Pont Reyes, CA	Marine	500	19.7
Kure Beach, NC (80 ft. from ocean)	Marine	533	21
Galeta Point Beach, Panama CZ	Marine	686	27
Kennedy Space Center, FL (beach)	Marine	1070	42

- **ASM documented this site as one of the most corrosive naturally occurring environments.**

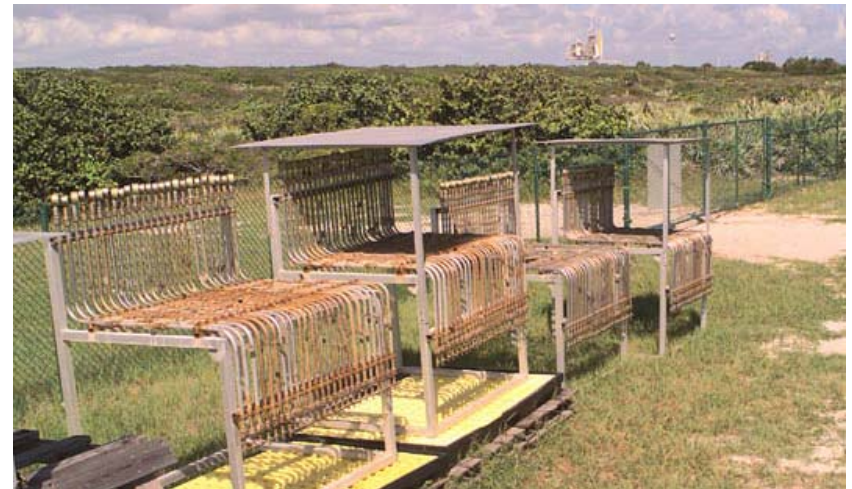
Corrosion Resistant Tubing Materials

- **304 stainless steel tubing is susceptible to pitting corrosion and stress corrosion cracking (SCC).**
- **Tubing replacement hopes to:**
 - **Increase service lifetime**
 - **Improve safety**
 - **Diminish maintenance costs**
 - **Reduce downtime losses**

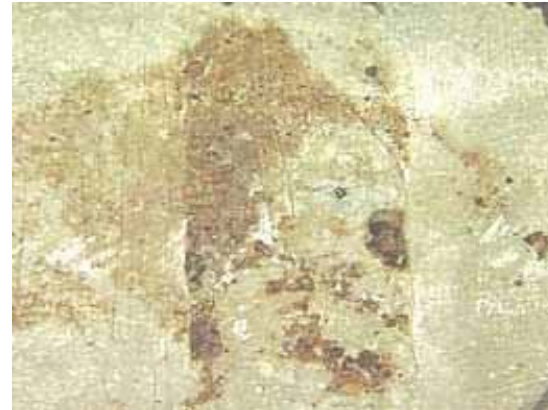
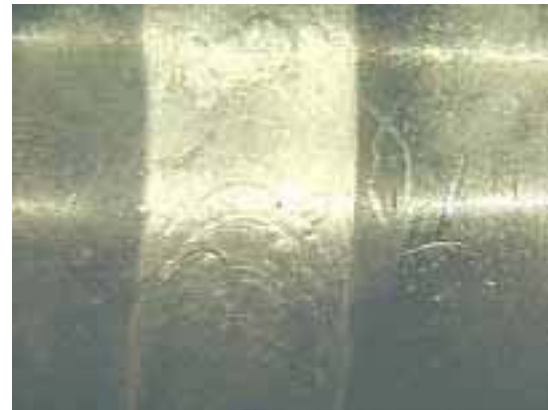
Results of Environmental Exposure

- **304L and 316L displayed inadequate corrosion resistance in the KSC launch environment**
- **Pitting corrosion caused both the 304L and 316L alloys to leak in less than 2 years**
- **The AL6XN alloys displayed improved corrosion resistance in the KSC launch environment**

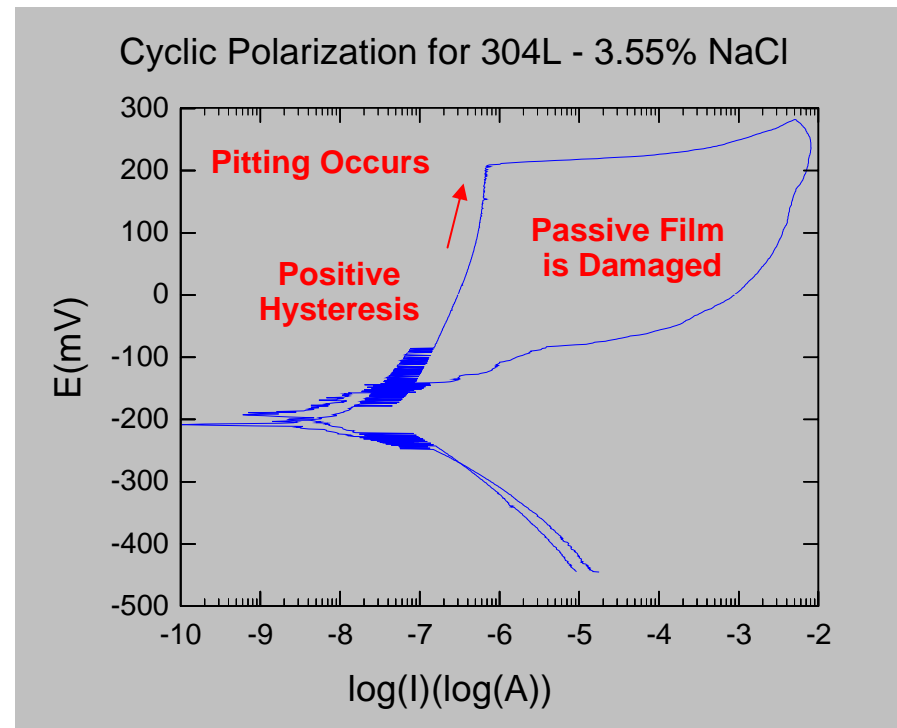
Electrochemical Investigation of the Corrosion Behavior of Metal Alloys in the STS Launch Environment

- DC and AC electrochemical methods of analysis were used in conjunction to atmospheric exposure
- Marine and launch pad conditions were simulated
- A correlation between the electrochemical and atmospheric exposure at the beach corrosion test site was made

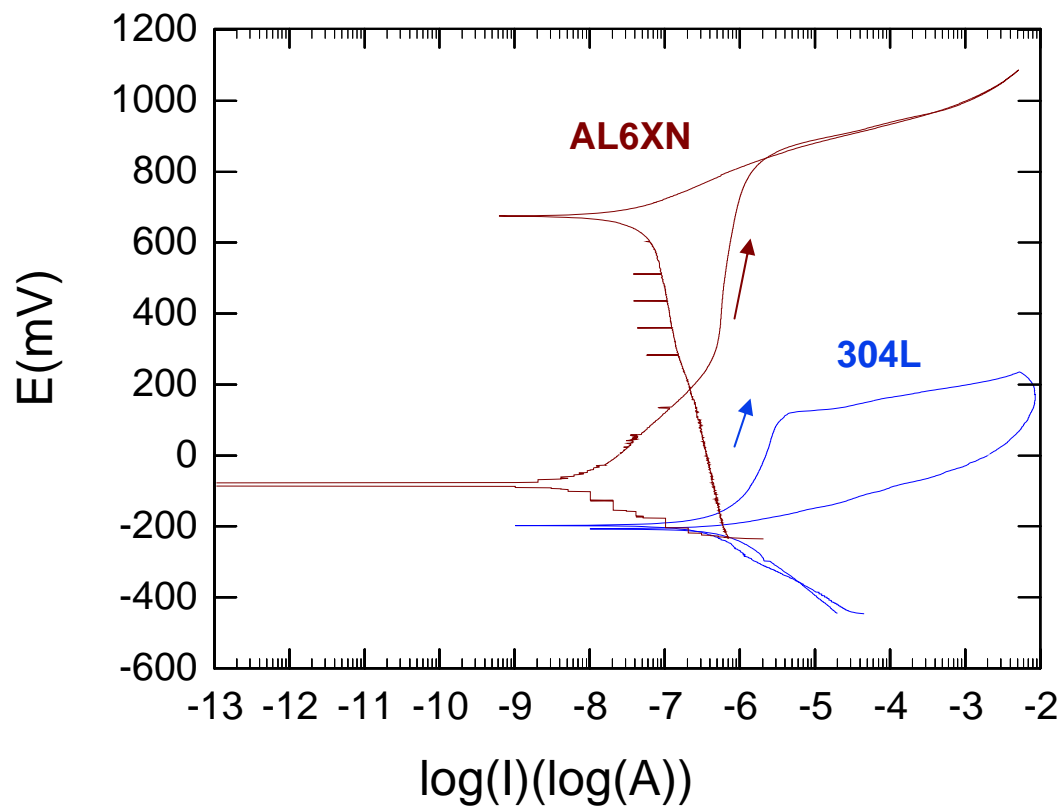
Cyclic Polarization Scans of 304L and AL6XN (3.55% NaCl and 0.1N HCl)
