Volume 2, Number 1
Spring 2006
Top Stories

NAVSEA Looks to Composite Technology to Improve Warship Components

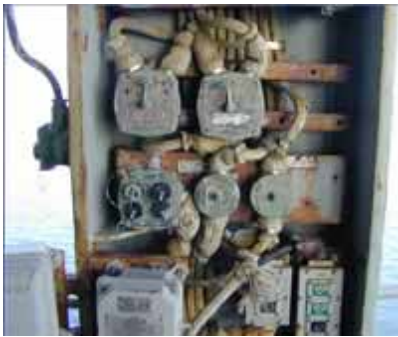
Corroded brass electrical boxes are a costly and time-consuming maintenance problem on Navy vessels. Photo courtesy of NAVSEA.

It may be surprising to learn, therefore, that one of the carrier's principal sources of corrosion-related maintenance challenges involves the metallic boxes that house the ship's electrical equipment, indicator lights, and connectors. For sailors who operate the ship, electrical-box failure causes critical operational and communications problems that must be resolved in the short term with extension cords, hand signals, and other undesirable means.

the brass, aluminum, and steel housings on a single carrier can cost more than \$1 million over a 10-year period. In addition to maintaining the boxes themselves, which generally requires repainting and repair every three years and replacing half the boxes every six years, the brass boxes cause galvanic corrosion of the ship's adjoining steel superstructure and mounting hardware, which requires further repair.

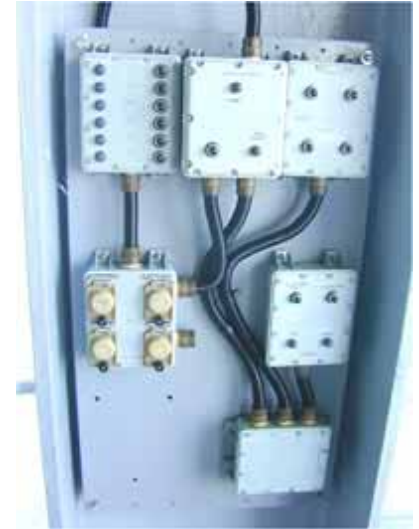
The new composite electrical box is expected to have a lifetime of 30 years and avoid millions of dollars in man-hours, repair, and replacement. Photo courtesy of NAVSEA.

Constructed of gray, fiberglass-reinforced Ultem resin with stainless steel hardware, the boxes incorporate durable, spring-loaded covers that are easy for sailors to use. The covers are designed to close automatically, preventing electrical connector corrosion. The Ultem/fiberglass material is lightweight, fire retardant, inherently stable in ultraviolet light, and durable enough to pass Navy shock requirements.

The new composite boxes will still require some maintenance, but that is largely related to electrical system adjustments such as tightening wires and cleaning contacts. Even then, only an estimated 10 percent of boxes will be affected because of the improved latch system.
