Volume 3, Number 2
Summer 2007
Featured Projects

NASA Engineers Evaluate Innovative Technique to Detect Hidden Corrosion

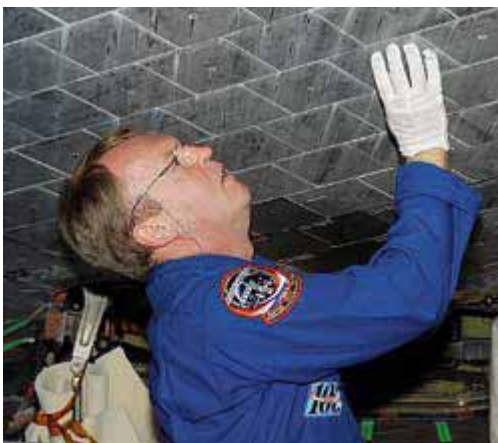
Mission Specialist Andy Thomas inspects thermal protection tiles on the Space Shuttle in 2005. Photo courtesy of NASA.

Before every launch and after each landing, NASA's experts inspect all Space Shuttle systems thoroughly, including the thermal protection tiles. The thermal protection system is critical to the Space Shuttle's ability to travel to and from space. The system not only allows the Shuttle to withstand the thermal cycles experienced in space, but it also enables it to return through the Earth's atmosphere, when temperatures reach as high as 3,000°F. As effective as the tiles are, however, they cause problems for NASA inspectors.

The Shuttle tiles are relatively straightforward to inspect for damage. The problem for NASA inspectors arises because the tiles get in the way of inspection underneath them, where there may be hidden corrosion or other damage.

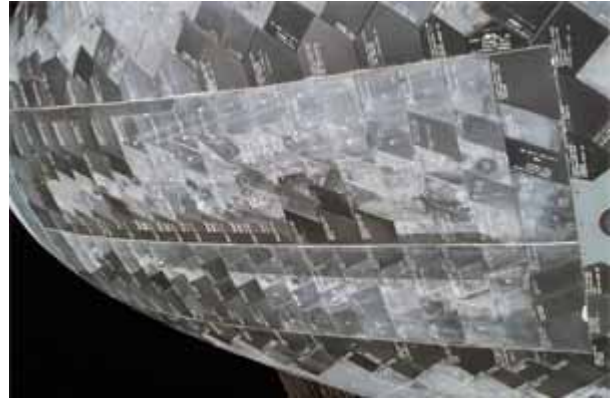
A close-up of thermal protection tiles on the Space Shuttle. Photo courtesy of NASA.

The tiles provide almost complete coverage of the substructure, but there are very small gaps between tiles that are filled with a ceramic-coated fabric. While these tiles and gap fillers are an excellent barrier to the extreme thermal environments of space and re-entry, the substructure is not completely protected from the various extreme environments the Shuttle encounters. Therefore, the metallic structure is still susceptible to corrosion, wear, and damage.
