Evaluation of Fastener Treatments for US Marine Corps Ground Vehicles

Darrell S. Dunn and Leonardo Caseres
Southwest Research Institute
San Antonio, TX 78223

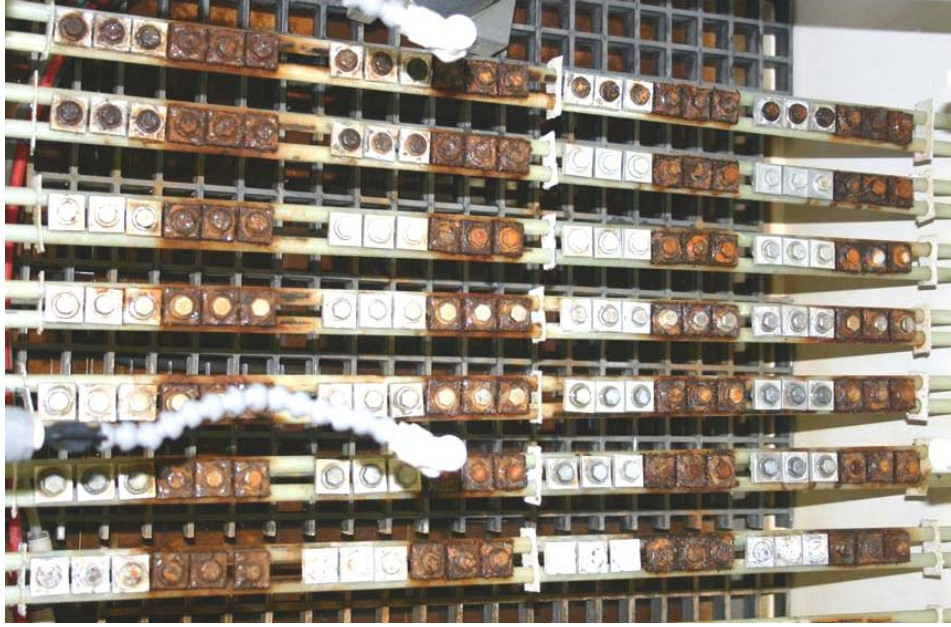
Fig. 1: Top view of the fastener assemblies inside the atmospheric exposure chamber.

The assemblies, prepared in triplicate, were placed in a cyclic environmental test chamber and exposed to a salt-water spray cycle of a mixture of NaCl, CaCl₂, and NaHCO₃, a high temperature drying cycle, and a high humidity cycle in accordance with the GM 9540P standard test protocol (3). Test exposures ranged from 1 to 90 days and were continuous with no intermediate inspection or maintenance. Fig. 1 shows a photograph of the actual experimental setup.

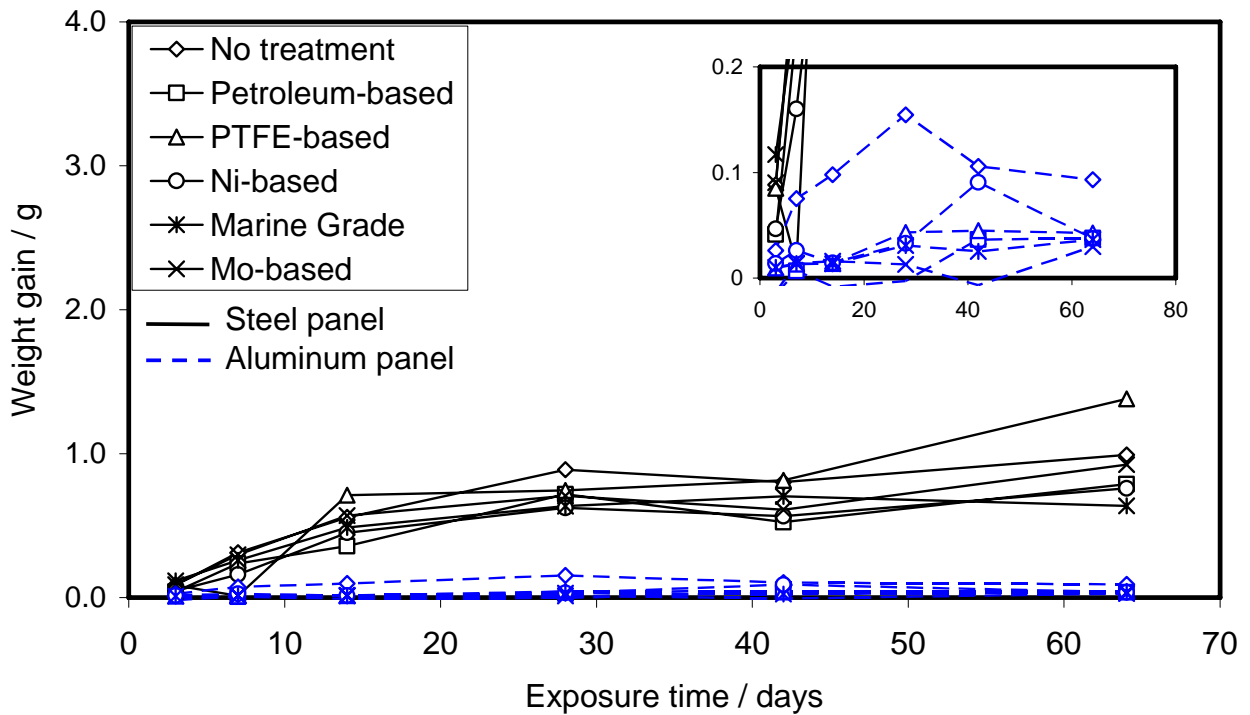
Fig. 4: Weight gain of the 316 stainless steel bolts in 1018 steel and 6061 aluminum alloy panels.

Figs. 2 to 6 show the average weight gain as a function of exposure time for the various treated and untreated bolt materials mounted in steel and aluminum panels. Both treated and untreated fastener assemblies showed an apparent weight increase with exposure time, which may be attributed to the accumulation of corrosion products that were not removed by rinsing. Although the increase in weight is a result of corrosion, the measured weight changes cannot be used to estimate corrosion rates, because the net weight change is the result of both weight gain due to corrosion product accumulation and weight-loss due to spallation of corrosion products, which cannot be accurately measured. The weight increase trends for all bolts examined with and without thread treatments mounted in steel panels were comparable, attaining over a ~3% weight increase for up to a 90-day period, suggesting that the use of thread treatments did not alter the buildup of corrosion products responsible for the increased weight after exposure of the untreated fasteners in steel panels. Similar observations were recorded for the treated and untreated bolts mounted in aluminum reaching <1.5% weight increase for up to a 90-day period. Overall, weight loss measurements of the untreated and treated bolts in aluminum panels were ~10% of the weight increase noted for the steel panel assemblies as a result of the smaller amount of corrosion products deposited on the aluminum compared to those observed on the steel panels. Light corrosion of the aluminum was noted in all cases in the crevice region between the washer and the aluminum panel.

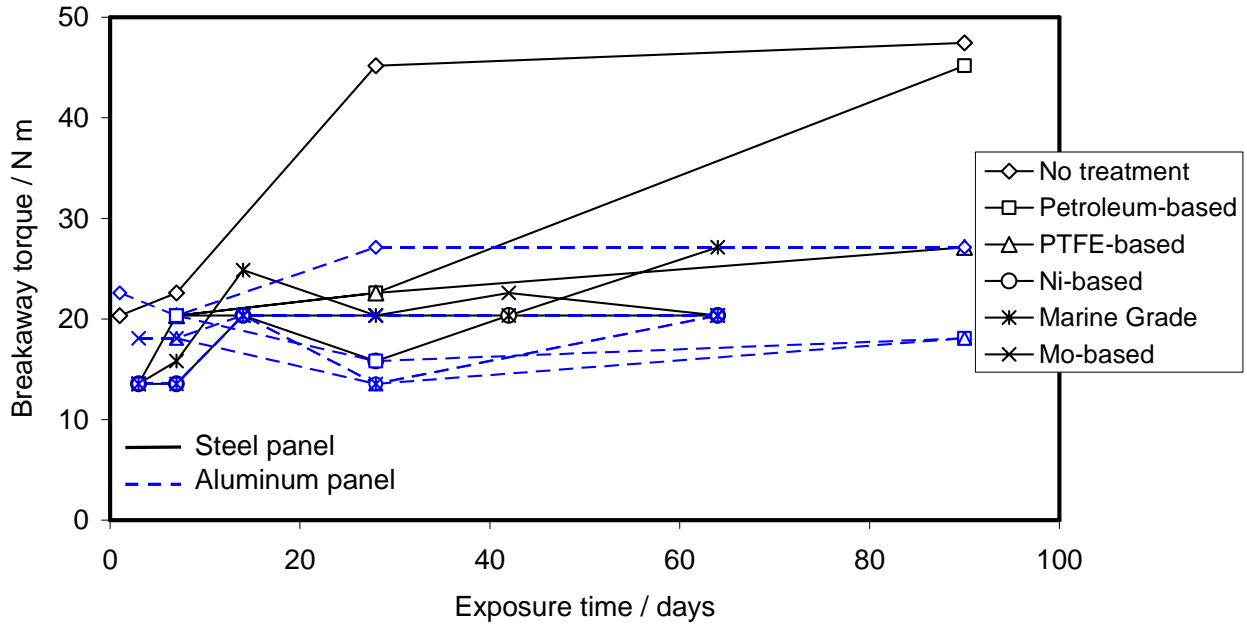
Fig. 7: Torque required for removing cadmium-plated bolts in 1018 steel and in 6061 aluminum alloy panels.

Figs. 7 to 11 show the results of the breakaway torque as a function of test exposure time for the treated and untreated fastener materials in steel and aluminum alloy panels. For up to 7 days of exposure, the breakaway torques for the cadmium-plated and black oxide-coated steel bolts (Figs. 7 and 8, respectively) were comparable to the respective installation torques, suggesting no significant corrosion or seizing of the threaded components. However, the breakaway torques increased significantly after 28 days for the untreated fastener materials, resulting in component failure as well as galling of the threads in some assemblies as illustrated in Fig. 12. Increased breakaway torques were also noted for the bolts treated with either the petroleum-based or PTFE-based anti-

seize after a 28-day exposure, but these torques were smaller than those recorded for the untreated bolts. The increased breakaway torques, more significant for the case of the cadmium-plated steel bolts, can be associated with both corrosion products accumulated on the steel panels and the bolts as exemplified in Fig. 13. Comparable observations have been reported by Brickford (4), Peterson et al (5), and Morrison (6). The smaller breakaway torques observed for the black oxide-coated bolts despite the significant accumulation of corrosion products around the hex of the black oxide-coated bolts can be attributed to extensive cleaning needed prior to removing the fastener, which may have mechanically loosened the fastener. Regardless of the increased breakaway torques, no failures were observed in any of the petroleum-based or PTFE-based treated bolts. Nevertheless, thread galling was noted on all cadmium-plated and black oxide-coated bolts treated with the petroleum based anti-seize after 90 days and with PTFE-based anti-seize after 28 and 90 days of exposure.

Results obtained with the cadmium-plated and black oxide-coated bolts in aluminum alloy panels are shown in Figs. 7 and 8, respectively. For both untreated fastener materials, the breakaway torque slightly increased for up to 28 days and remained nearly constant afterwards, attributed mainly to the relatively low strength of the aluminum panels. Thread galling and thread damage were noted on the untreated cadmium-plated and black oxide-coated bolts exposed for 28 days. In contrast, no significant increase in breakaway torque was noted for fasteners treated with either petroleum-based or PTFE-based anti-seize. Moreover, thread galling was observed in one black oxide-coated bolt treated with petroleum-based anti-seize and no thread galling was noted in any of the PTFE-based treated fastener assemblies.

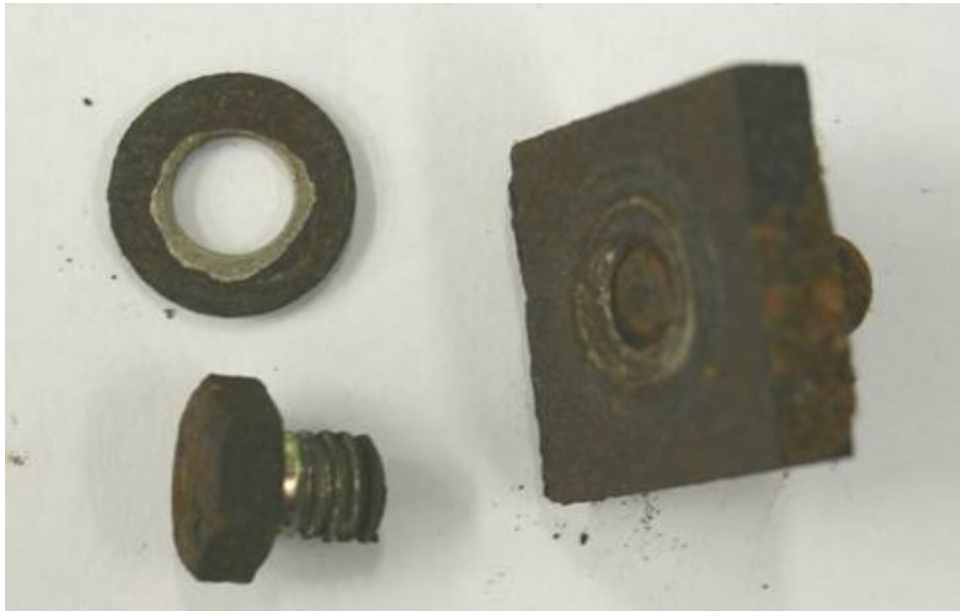
Fig. 12: Photograph of a broken untreated black oxide-coated bolt in a 1018 steel panel after 28 days of exposure. Severe galling/seizing was noted after 28 days of exposure.

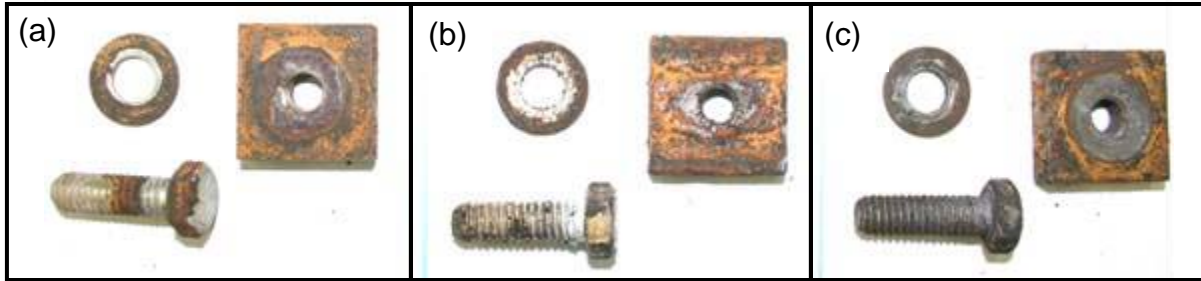
Fig. 13: Photograph of disassembled test pieces of cadmium-plated steel/steel panel assemblies after exposure in the atmospheric chamber for a period of 7 days. For the untreated fastener (a), thread corrosion is visible. The PTFE-treated bolt (b) still retained much of the white colored fastener treatment and the silver colored petroleum-based anti-seize (c) is also visible after 7 days.
