Volume 2, Number 1
Spring 2006
Technology

Coast Guard Solves Slat Corrosion on Twin-Engine Falcon

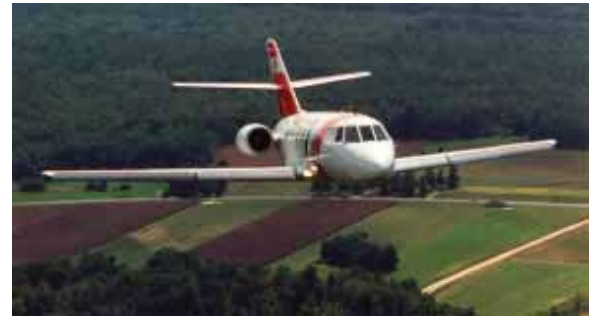
The highly corrosive sea environment—particularly its temperature and moisture extremes—tends to degrade the wing's leading edge.

This wing section includes an instrumental slat system prone to corrosion and expensive overhaul measures, said Lt. Commander Charles Hatfield, an HU-25 Engineering Officer. The slat system is constructed from 2024-T4 aluminum with steel fasteners.

"The slat is a high-lift device that consists of a double skin of aluminum that provides a passage for warm air de-icing," Lt. Cdr. Hatfield explained. "The wing's leading edge houses the thermal anti-icing system and must be capable of withstanding environmental attack while operating at high temperatures."

The Coast Guard's Aircraft Repair and Supply Center has had little success with corrosion-prevention methods other than the polymer coating, Hatfield said. Waxing the anodized slat surfaces proved less than successful. Other less fruitful methods included coating the slats with original equipment manufacturer-recommended polyurethane, as well as ceramic and liquid glass. So Hatfield's team authorized the use of Sermatech's Shorcoat™ on 13 slats on five aircraft that had logged more than 900 flight hours in two Coast Guard air stations in Miami, Florida, and Corpus Christi, Texas.

"The polymer coating has a color that is very similar to the original anodizing of the slats," Hatfield said. "It appears to hold up very well to temperature extremes and is erosion- and corrosion-resistant. The coating is also easy to repair in the field for any scratch or cut that may occur."

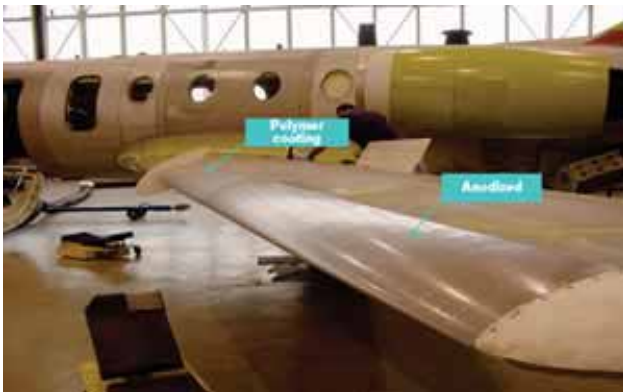
The color of a polymer coating used to protect the slat of a twin-engine Falcon resembles that of its anodized surface. Photo courtesy of U.S. Coast Guard.
