Volume 3, Number 2
Summer 2007
Featured Projects

Remote Imaging System Streamlines Analysis of Tank Coatings on Ships

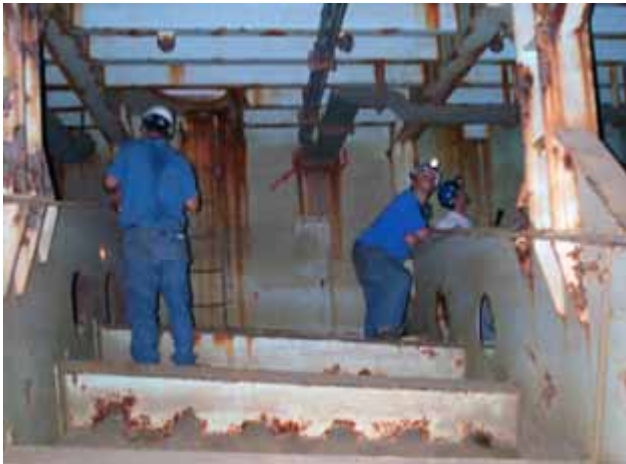
The Naval Research Lab has developed a table-top, computer-based system to improve upon the Navy's physical method of assessing ballast tank coatings. From left, Navy corrosion experts Rich Hays, Ted Lemieux, and Bill Groeninger inspect the tank interior of an LSD 41 amphibious combatant ship in 2002. Photo courtesy of Paul Slebodnick, Naval Research Lab.

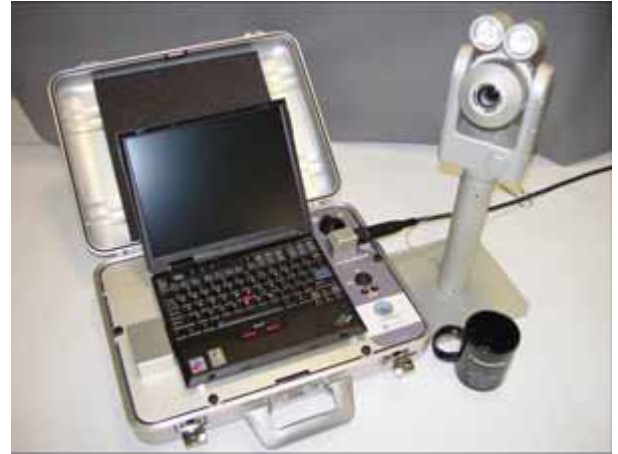
The ISIS consists of a hatch-mountable pan-tilt-zoom video camera, PC-based image viewing and storage, menu-driven software, and joystick camera controls. In addition to providing live video feed of a tank's interior, a typical ISIS assessment collects 12 to 30 still images that are representative of the overall condition of the tank. These are subsequently analyzed pixel by pixel using corrosion detection algorithms (CDAs). The CDAs assess color, wavelet edge, grayscale, fusion, and quantitative damage, and ultimately determine the percentage breakdown of the coating. The coating sites are categorized into four quality levels that range from excellent (less than .03 percent surface degradation) to poor (more than 10 percent degradation). The camera's filming positions are stored in the computer so that future assessments can easily and precisely return to the same areas within the tanks.

The Naval Research Laboratory is using an Insertable Stalk Imaging System (ISIS) to visually and quantitatively assess the condition of the coating inside a ship's ballast tank. Photo courtesy of Naval Research Lab.

"During our research, we were unable to find an 'off the shelf' system for the kind of optical assessment we wanted, so the laboratory developed its own in conjunction with industry partners," said Groeninger. "The resulting product, called an Insertable Stalk Imaging System (ISIS), can visually and analytically assess coatings inside tanks in a way that is more accurate, quantitative, and repeatable than the traditional physical assessments."
